ACTIVE faults

IN EAST BATON ROUGE PARISH, LOUISIANA

Richard P. McCulloh

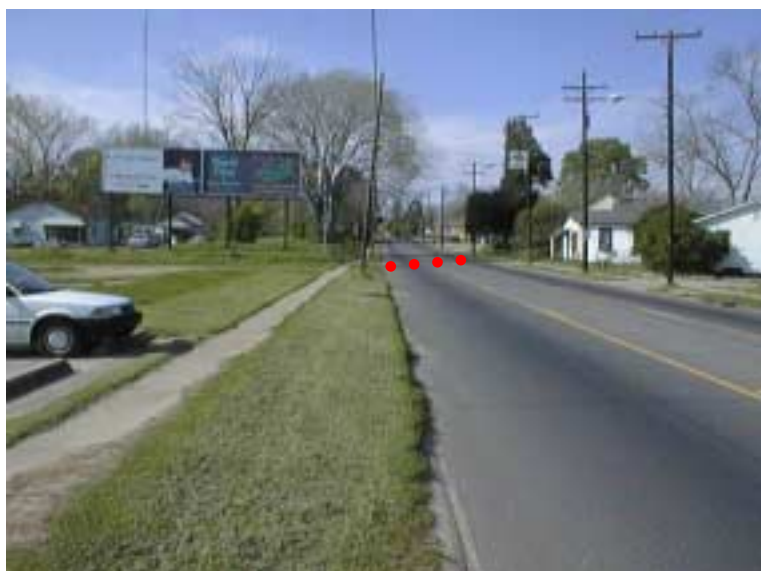
Figure 3. Photograph of the fault-line scarp of the Baton Rouge fault (in the far distance) where it traverses Highland Road not far north of LSU. The fault here coincides with a terrace boundary, the one marking the Pleistocene-Holocene contact: the Prairie terrace (Pleistocene) on the upthrown side is juxtaposed against deposits of the current Mississippi River flood plain (Holocene) on the downthrown side.

The individual faults are recognizable at the surface in the parish as escarpments (long slopes that are fairly continuous and comparatively steep, facing in a consistent direction and separating more gently sloping surfaces on either side) having distinctive topographic expression (figures 2, 3). They were first described in the mid-1950s,¹ at which time they were corroborated by sub-surface information that had been produced in conjunction with the exploration for oil and gas. Though they do not produce detectable earthquakes, these faults are known to be active because of the cumulative damage done to structures located on and near certain fault segments over periods of years and decades. Examples of such damage include cracked road pavements, foundation slabs, and walls.

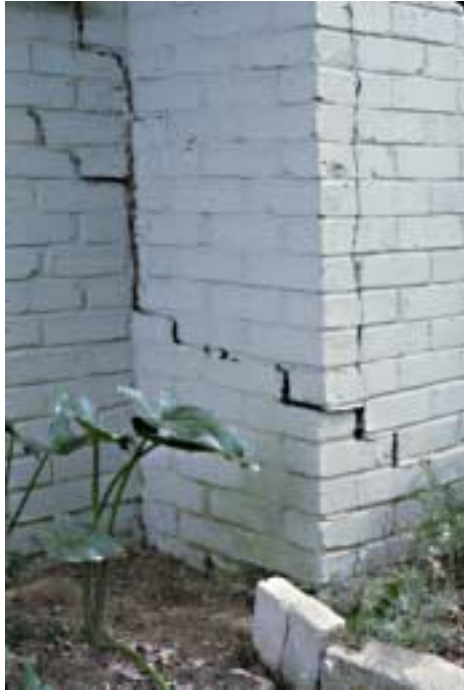
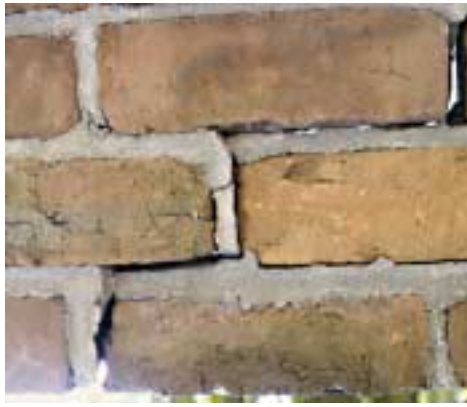
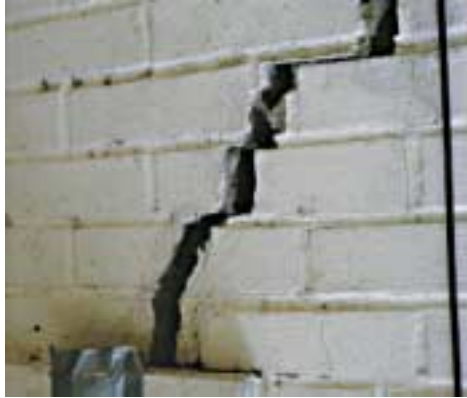
Damage to structures built on and near faults of the Baton Rouge system in East Baton Rouge Parish (from photographs taken in conjunction with the investigation of Roland and others 1981, on file at the Louisiana Geological Survey).
